NRL/MR/6180--05-8928

General Atomics Smart Microsensors — FY05 Shipboard Fire Test Results

December 12, 2005

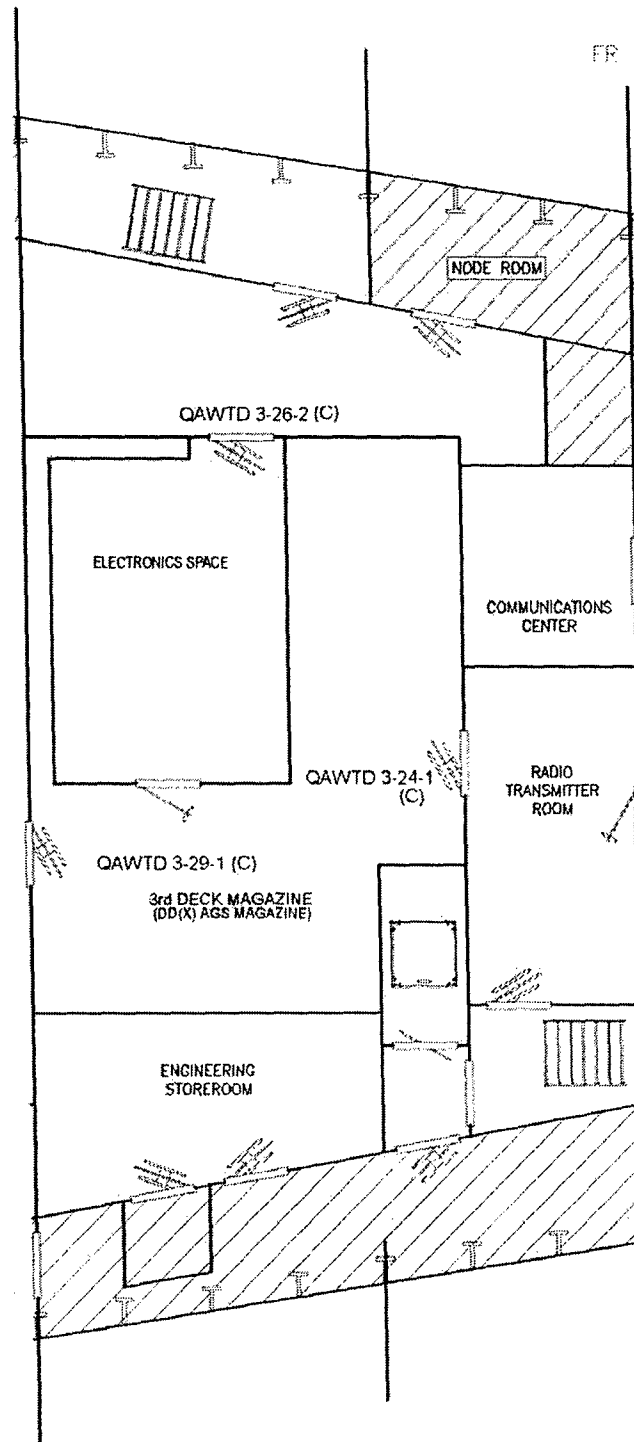
Fig. 1 — Layout of the spaces in the vicinity of the 3rd deck magazine

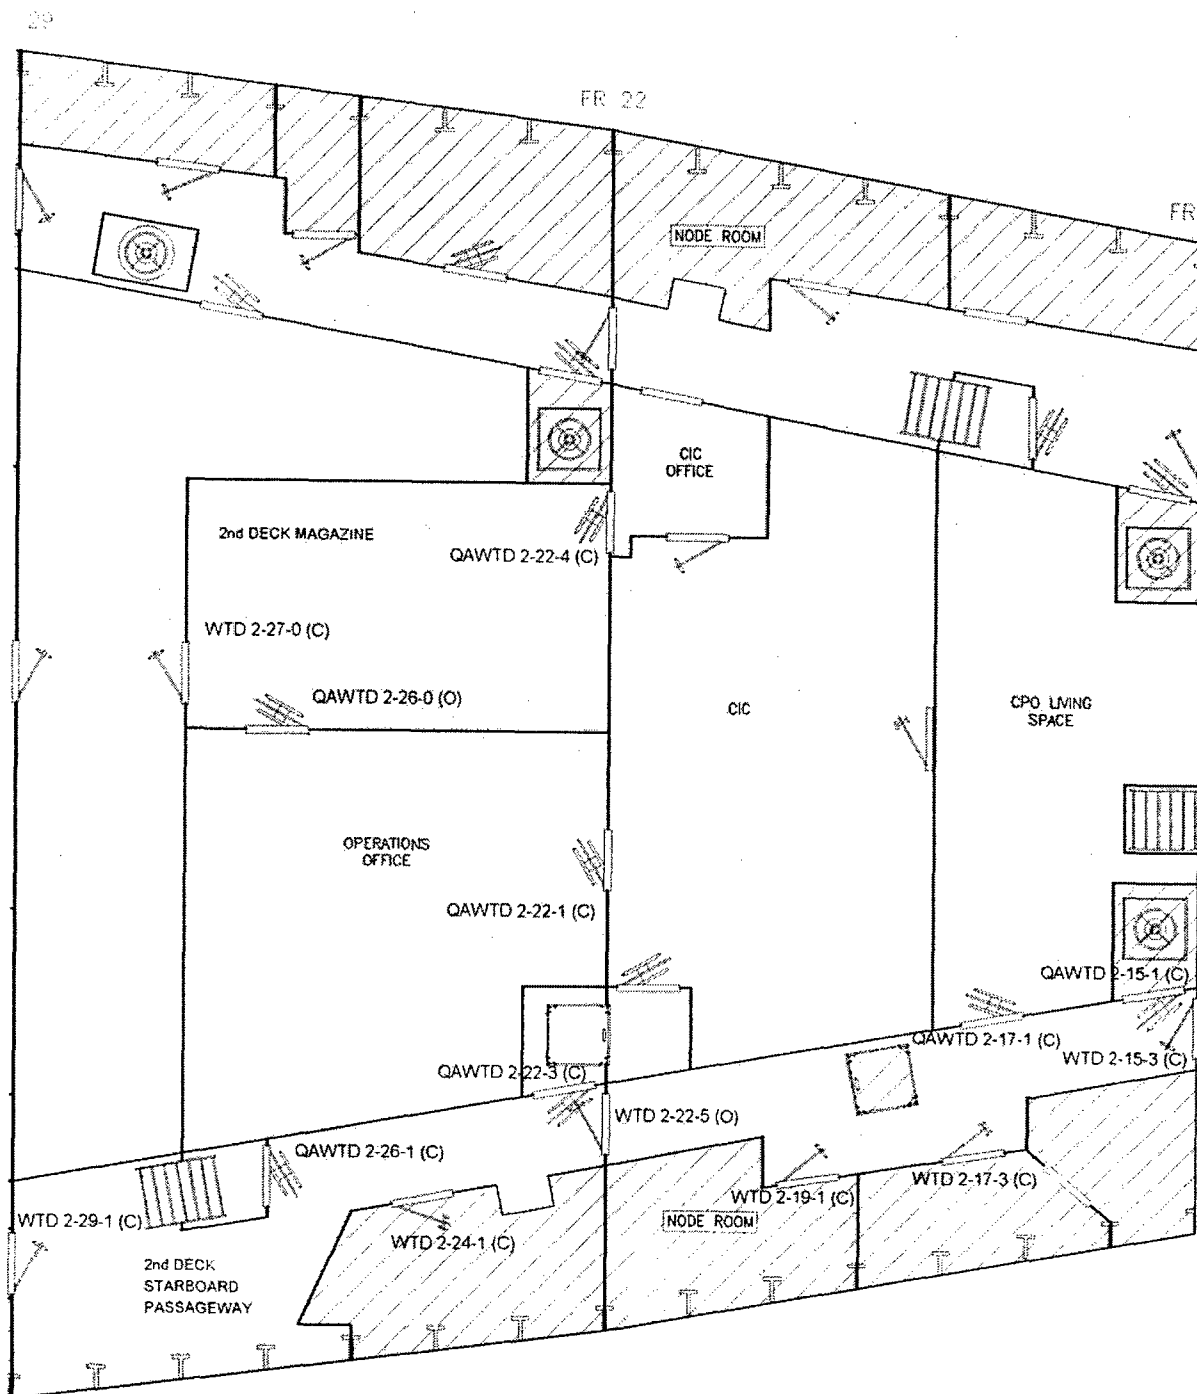
Fig. 2 — Layout of the spaces on the 2nd deck

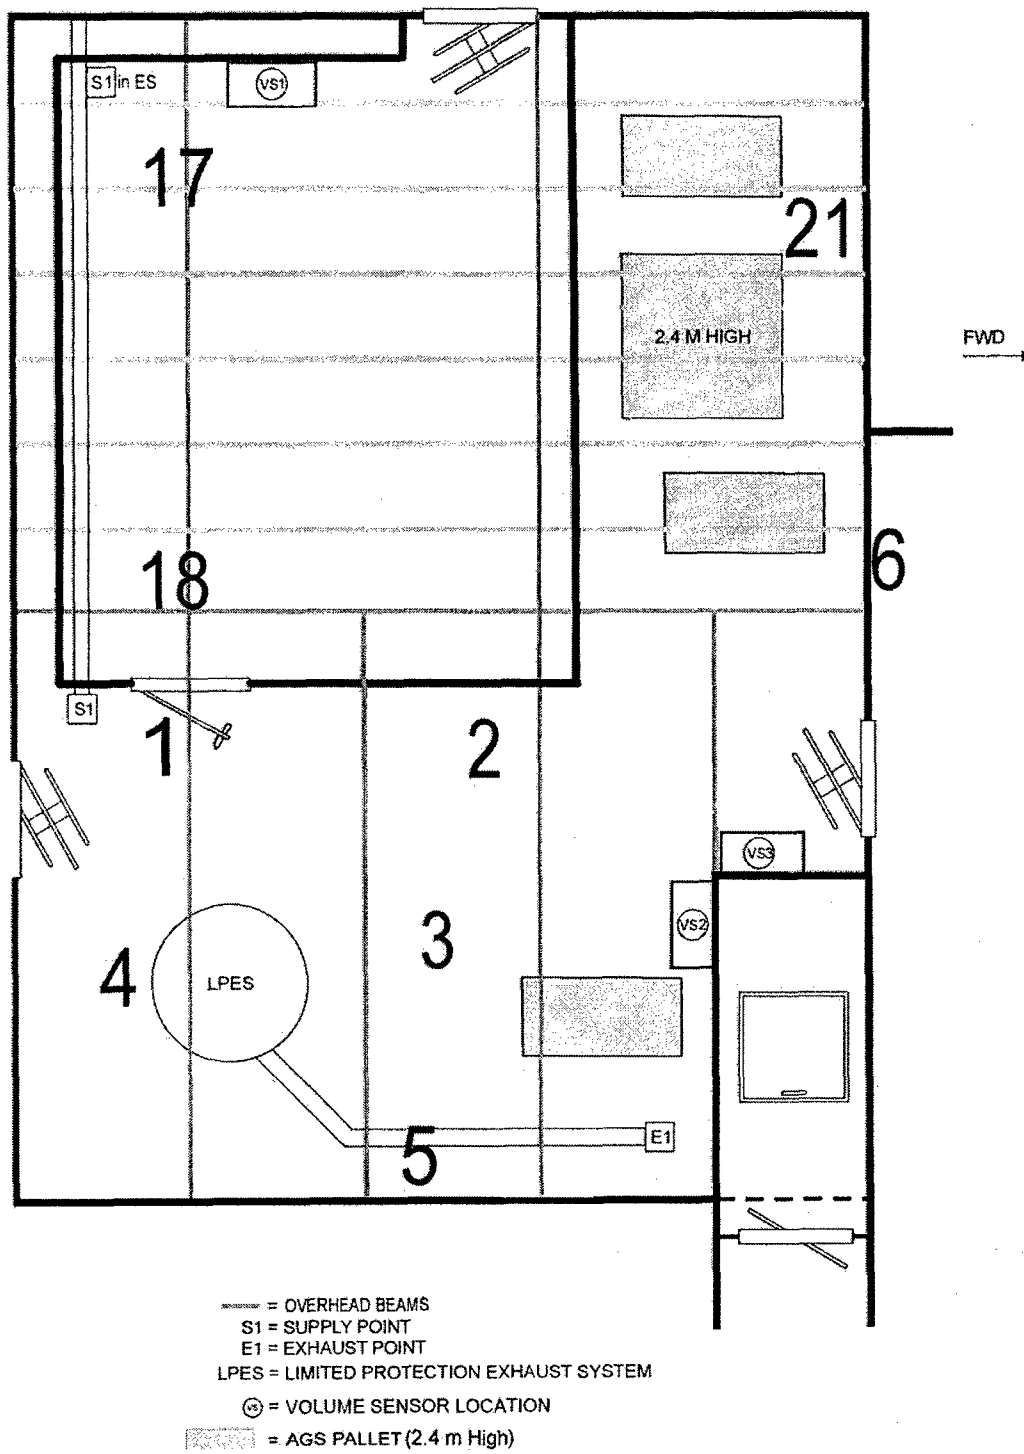
Fig. 3 — Layout of deck obstructions and source locations within 3rd deck magazine

In addition to the overhead beams, light fixtures, and a partial overhead grid in the 3rd deck magazine, obstructions, in the form of mock AGS pallets, were located on the deck within the compartment. The mock pallets were approximately 2.4 m (8.0 ft) in height 1.22 m (4.0 ft) wide and varied from 0.61 to 1.22 m (2 ft to 4 ft) in length. Figure 3 shows the layout of the mock AGS pallets and source locations within the 3rd deck magazine.

A variety of fire sources, nuisance sources, pipe ruptures and gas releases were used to expose the GA Smart Microsensors and spot-type detectors to a range of potential shipboard scenarios. Small fires were used to challenge the detection systems and provide performance results for early detection. Tables 4 to 7 present details of the fire sources, nuisance sources, the pipe ruptures, and gas release scenarios, respectively, that were used in this test series. Since these sources are specifically designed to challenge the multiple detection capabilities of the Volume Sensor system [13], a number of them were not applicable to the evaluation of the GA chemical sensor array. In general, the fire and the aerosol/smoke-based nuisance sources are relevant to this study. Most of the sources were conducted at deck level except the gas releases, which were generally at about 1.2 m above the deck. The height of the electrical cable fires and some nuisance sources (heat gun, radio, TV) were varied to provide both a range of test conditions and representative shipboard scenarios. Table 10 notes sources that were not placed on the deck and contains the height of the source above the deck. Source locations can be seen in Figs. 3 through 7.

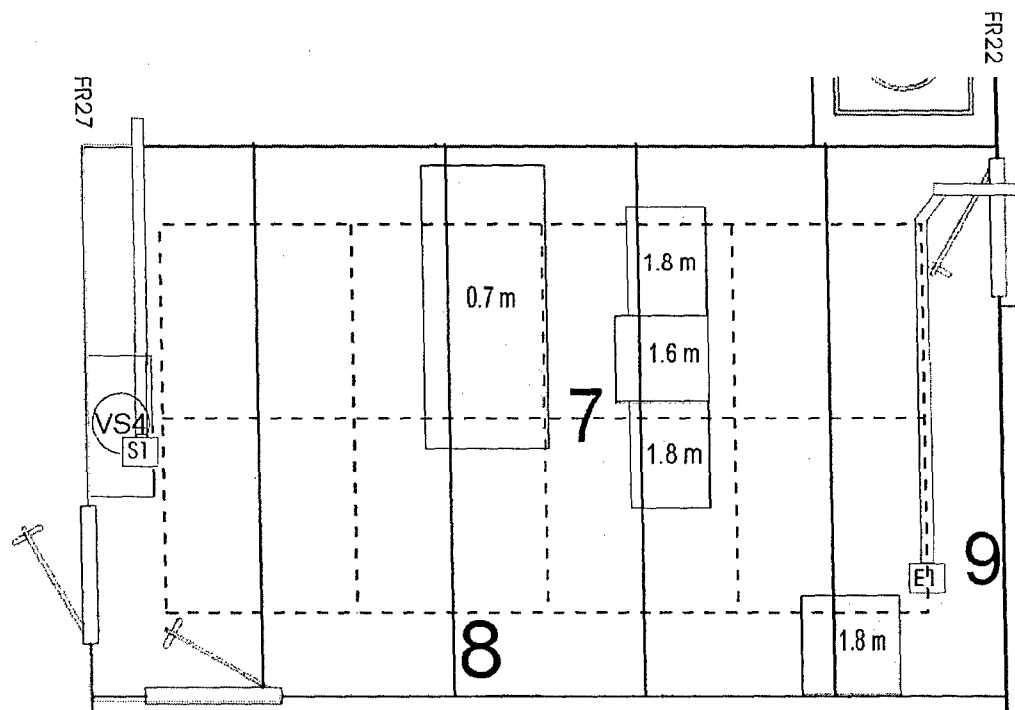
Fig. 4 — Layout of deck obstructions and source locations within 2nd deck magazine

In addition to the light fixtures, overhead (OH) beams, and the OH grid, cabinets were placed on the deck within the compartment. The cabinets varied in height (Fig 4) and were dispersed throughout the compartment. Figure 4 shows the source locations and layout of the cabinets within the 2nd deck magazine, the layout is similar to the layout used in CVN 21 Fire Threat to Ordnance [11].

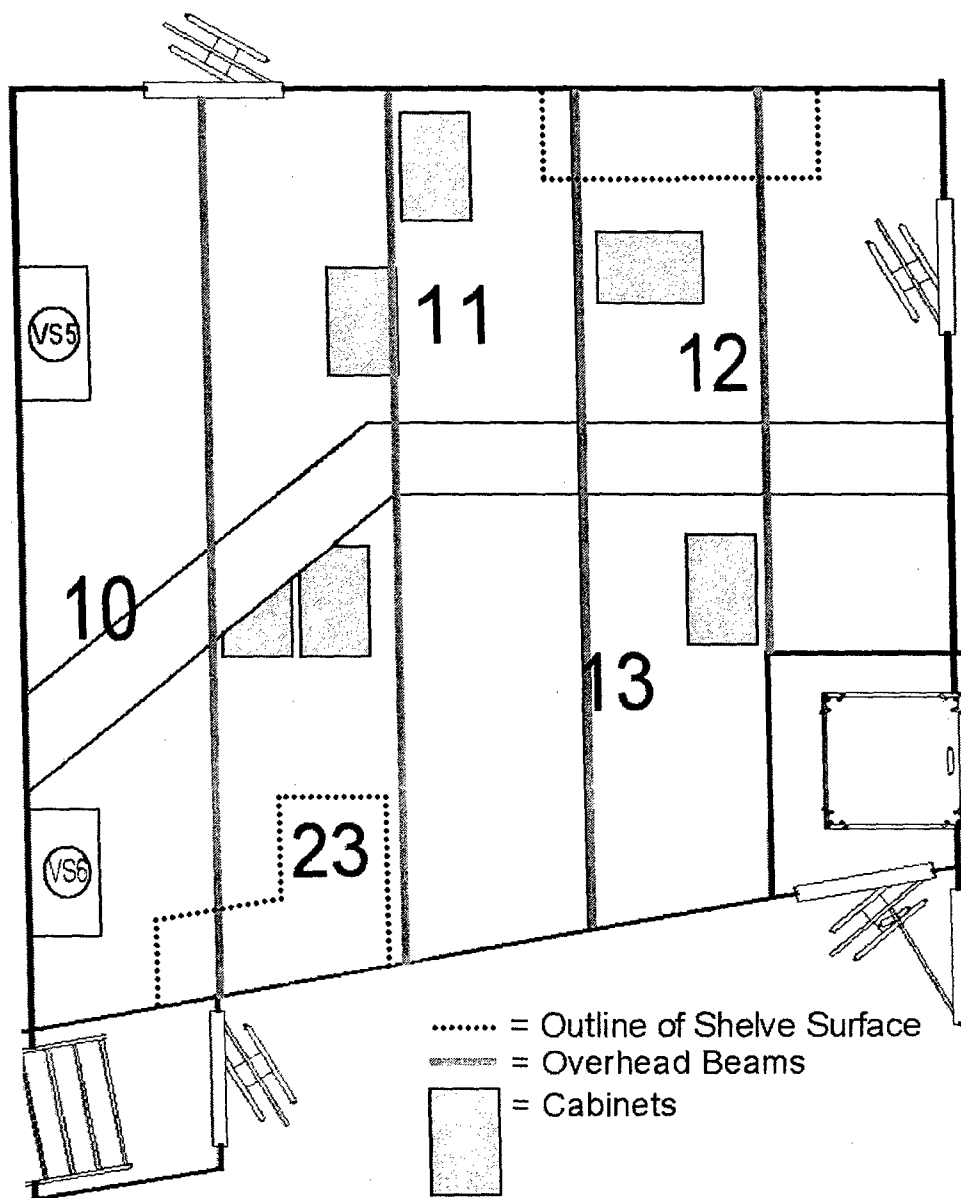
Fig. 5 — Layout of deck obstructions and source locations within 2nd deck operations office

Obstructions, in the form of cabinets, were placed in the operations office. The cabinets were dispersed throughout the compartment. Figure 5 shows the ventilation duct, source locations, and the layout of the cabinets within the 2nd deck operations office. Figure 6 shows the ventilation duct, source locations, and the layout of the cabinets adjusted to accommodate source location 22 within the 2nd deck operations office (tests VS5_35 – VS5_39).

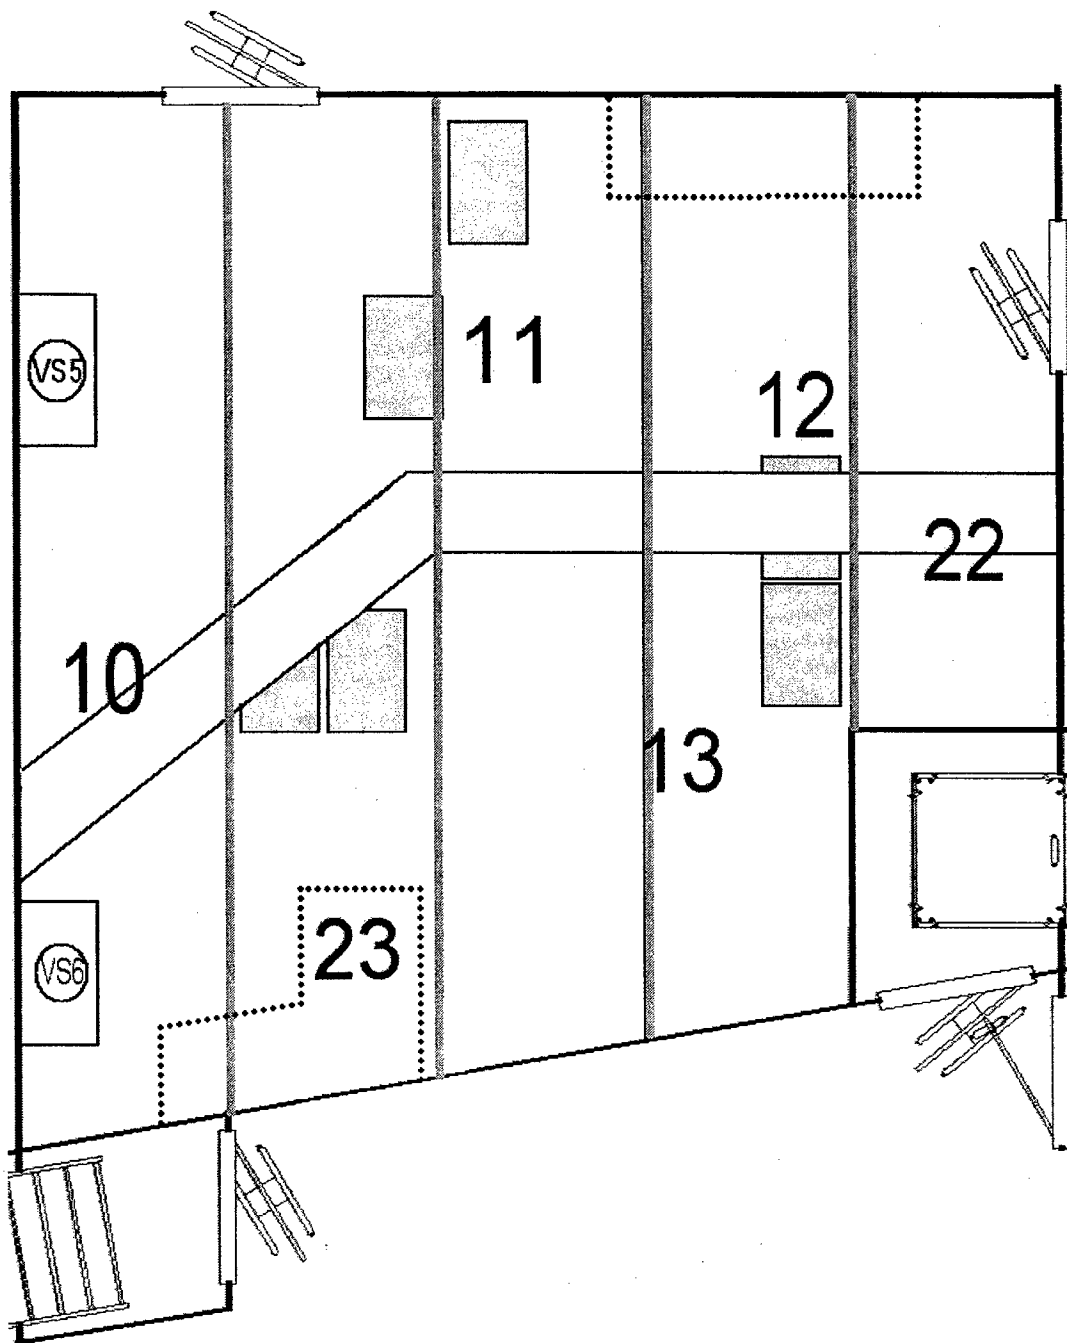
Fig. 6 — Layout of deck obstructions and source locations within 2nd deck operations office incorporating source location 22.

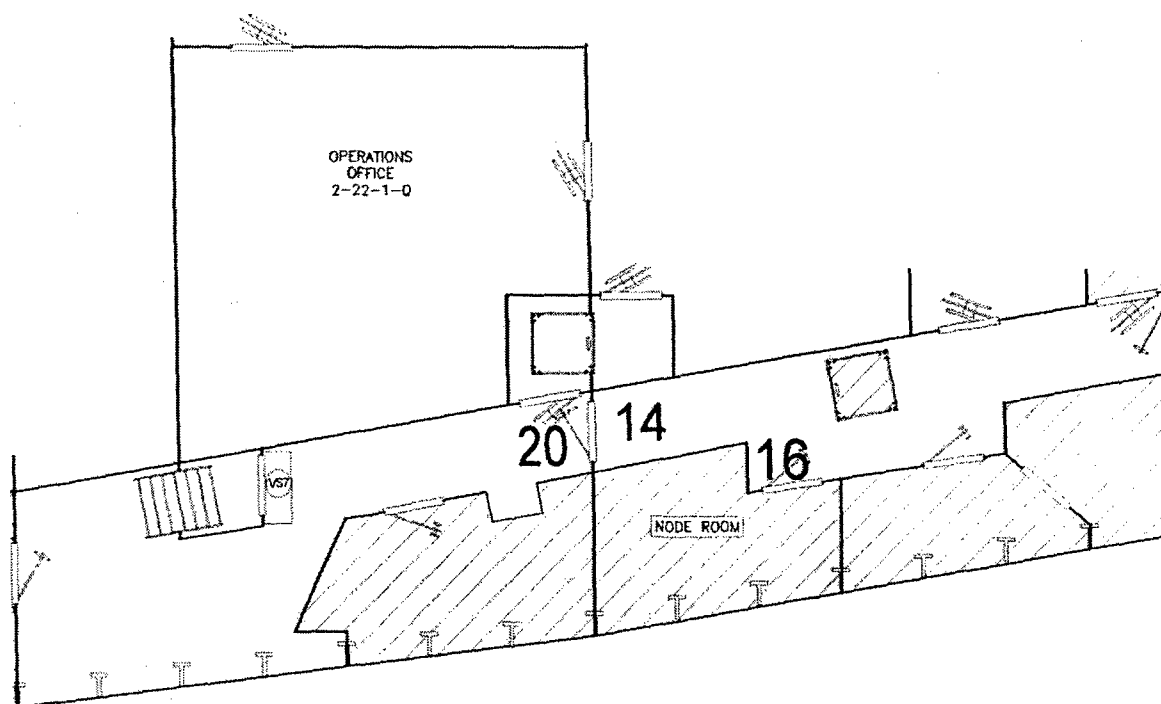
Fig. 7 — Layout of the 2nd deck starboard passageway source locations

The starboard Passageway on the 2nd deck of the ex-USS *Shadwell* was used as a test space. The overall dimensions of this space were 16.8 m (55.5 ft) forward to aft, 1.1 m (3.7 ft) port to starboard, and a height of 3.0 m (10.0 ft). A door separated the aft and fwd sections of the passageway. The door was left open during testing to elongate the passage way. Figure 7 shows the starboard passageway in relation to the operations office along with the source locations.

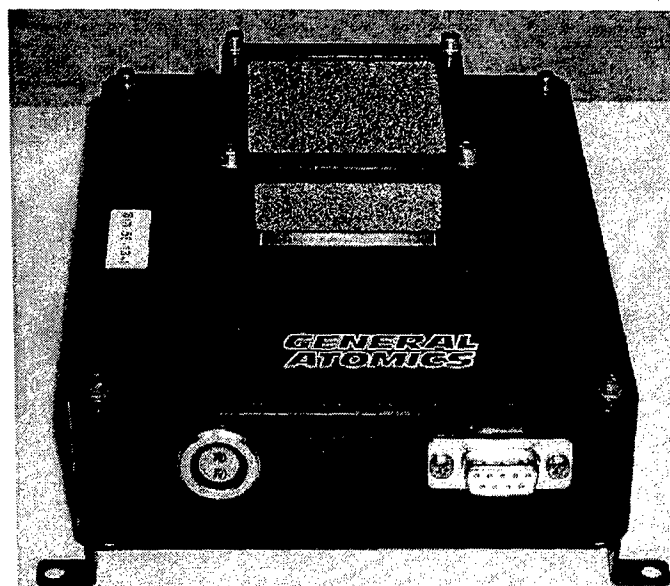
Fig. 8 – GA Smart Microsensor Prototype.

The GA microsensor prototype, shown in Fig. 8, is composed of a physical sensing system, graphical user interface software, and a 24 VDC power supply. The physical sensing system involves a microsensor array of economical, durable, high-temperature ceramic-metallic (cermet) sensor elements, shown in Fig. 9. An electrochemical (voltammetric) measurement technique was used to generate the complex response waveform from the microsensors. Voltammetry involves applying a varying potential (typically a triangular waveform) across an electrochemical cell and measuring the resultant current. The electrical characteristics of an electrochemical cell (i.e. current vs. voltage response) are influenced by the presence of analyte gases.

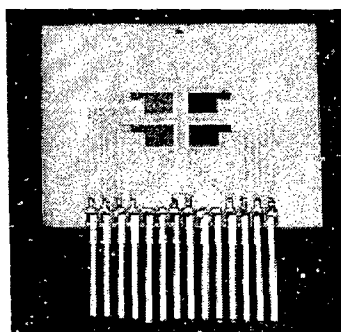
Fig. 9 – GA Chemical Microsensor Array.

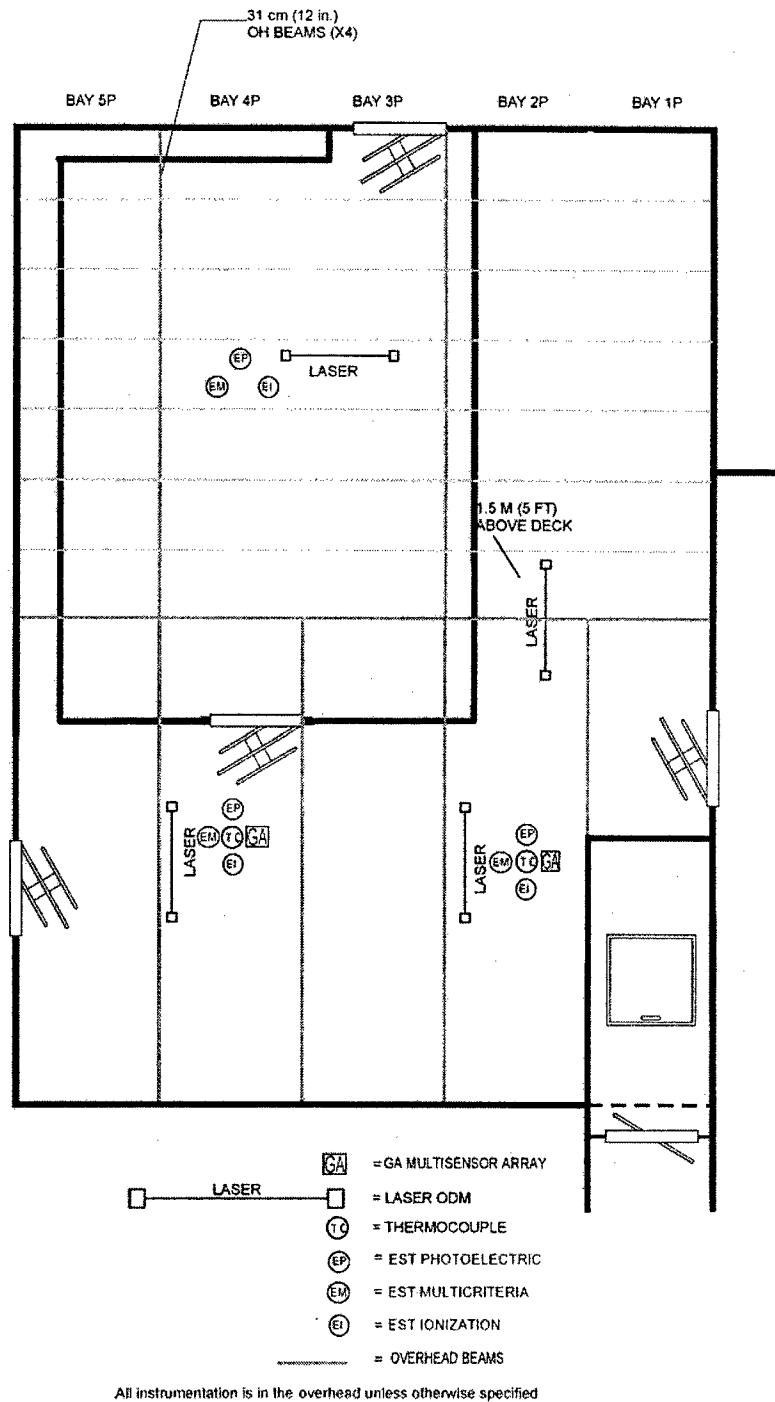
Fig. 10 — Layout of the GA sensor arrays, ODMs and smoke detectors in the 3rd deck magazine

In addition to the GA Smart Microsensors, instrumentation (see Table 9) was installed throughout the test compartments to measure temperatures and smoke density. The measurements were not directly utilized by the GA Smart Microsensors; however, they provided general space conditions and benchmarks for typical spot-type fire detection systems. Details on the instrumentation that was used for these measurements are discussed in Sections 4.6.1 through 4.6.3. The locations of the instrumentation are shown in Figs. 10 through 12. Figures 10 and 11

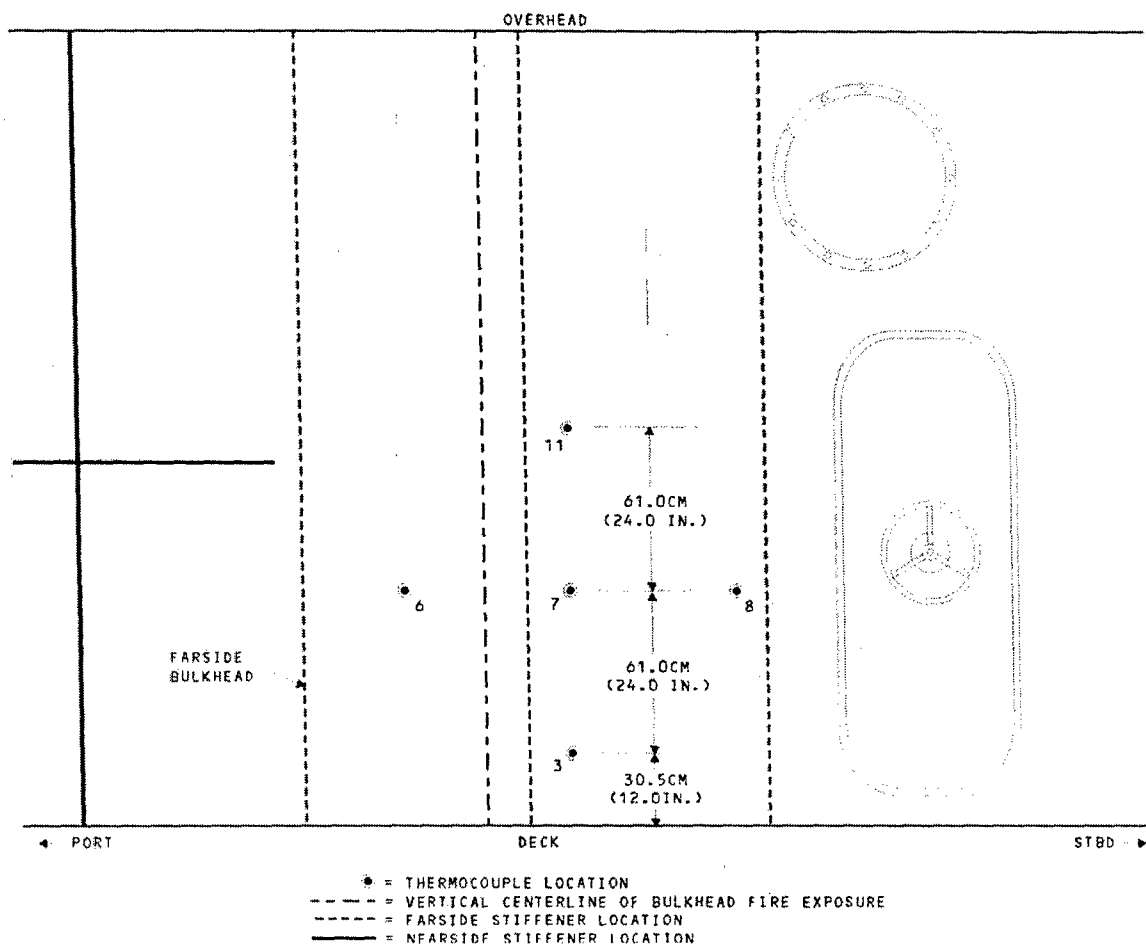
Fig. 11 — Locations of 3rd deck magazine forward bulkhead thermocouples

The overhead air temperatures adjacent to the detectors were measured using 1.59 mm (0.0625 in.) Type K Inconel sheathed thermocouples. A thermocouple was placed next to each detector cluster. The thermocouples were positioned at the approximate height of the detector heads, 10 cm (4 in.) below the overhead. The forward bulkhead of the 3rd deck magazine was instrumented with five thermocouples to map the steel temperature during the painted bulkhead heating scenario. The thermocouple locations on the 3rd deck magazine bulkhead are detailed in Fig. 11. Thermocouple trees were also used to measure compartment air temperatures. Each tree consisted of three Inconel-sheathed, type K thermocouples positioned 0.30 m (1.0 ft), 1.5 m (5.0 ft), and 2.7 m (9.0 ft) above the deck. Three TC trees were located in the passageway, one TC tree was located in the operations office, two TC trees were located in the 2nd deck magazine and two TC trees were located in the 3rd deck magazines.

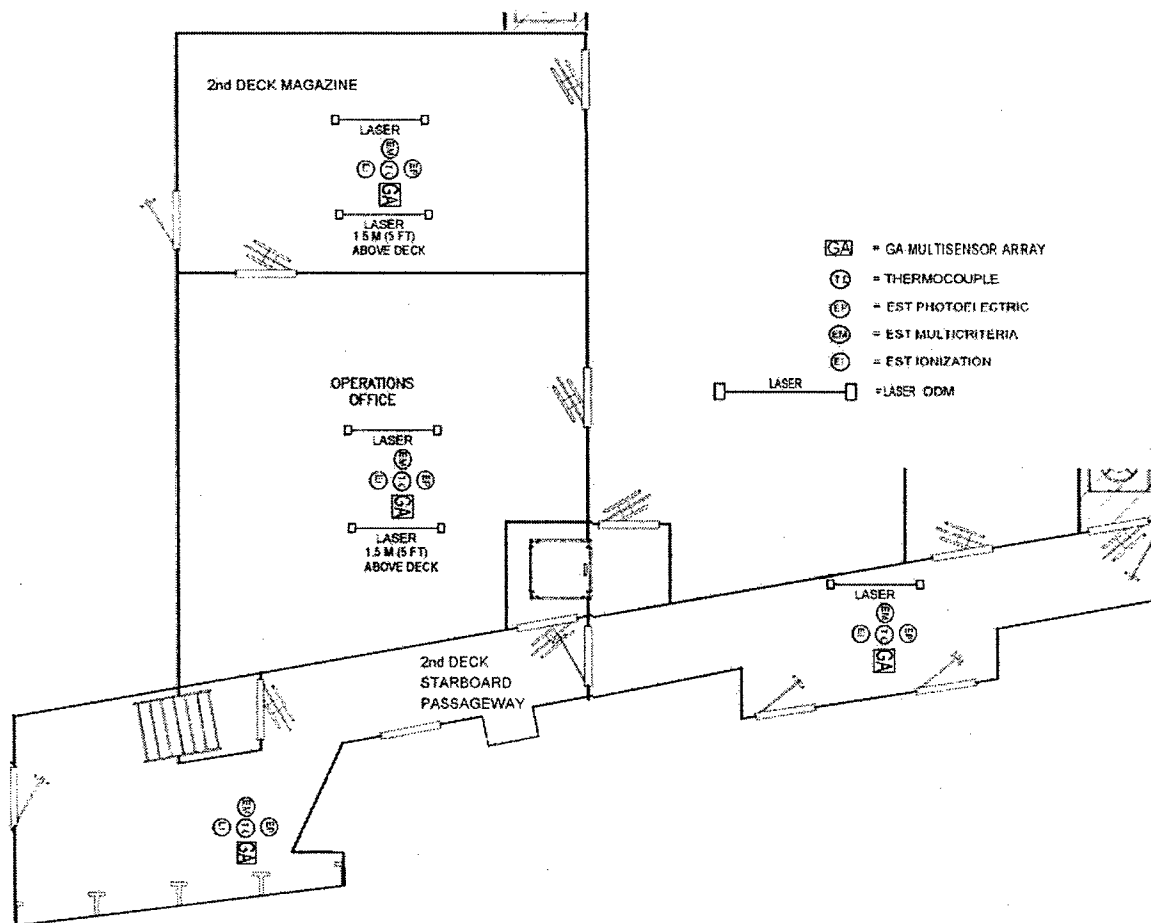
Fig. 12 — Locations of the GA sensor arrays, ODMs and spot-type detectors in 2nd deck test compartments
